IN-SITU EVALUATION AND LABORATORY TESTING OF

ASPHALT CONCRETE FULL-DEPTH RECLAMATION

CHANG-SEON SHON¹, ASSEL BISSENOVA², ELDAR SHARAFUTDINOV³, YESKENDIR ALDABERGEN⁴, NURDAULET KUTYMBEK⁵, JONG R. KIM⁶ & TOM SCULLION⁷

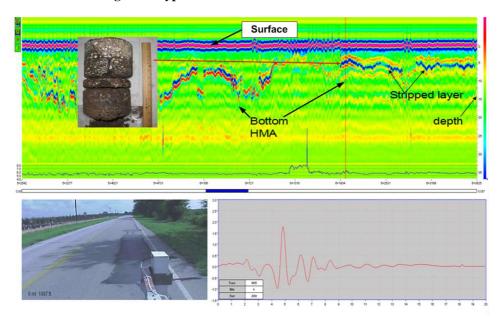
Figure 3: GPR Data and Core Sample (NB Direction) of FM 1887

Ground penetration radar (GPR) was used to assess the pavement structure such as base layer thickness and layer interface condition. Figure 3 presents typical GPR data and a typical core from FM 1887 which is about 1 mile of pavement from 5.5 to 6.5 miles north of Monaville. The surface is the solid red line and the depth scale is on the right of the figure. The upper plot is color coded GPR data. The most significant feature is the strong blue reflection at some depth below the surface. The core was taken at the location marked. This core shows severe moisture damage. The only good part of the HMA layer is the top 2 inches, the deeper in the HMA the worse the condition. Stripping of this severity is common in many gravel hot mixes made with uncrushed river gravel which were placed typically before the use of anti-stripping agents and before the crushed face requirement. It is very common in many areas in East Texas.

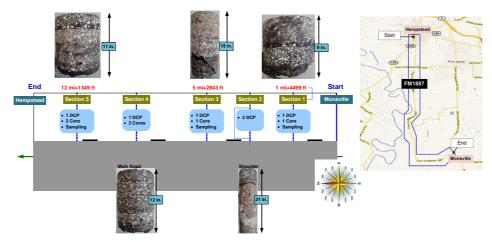
Figure 4: Asphalt Concrete Core Samples and Material Sampling Locations of FM 1887

The existing pavement structure characterized by GPR was further verified using dynamic cone penetrometer (DCP) profiles and core sample analysis. As shown in Figure 4, five core locations were selected for validation of the pavement structure and for collecting materials for laboratory testing. These locations were in the northbound direction from Monaville.

Basically, the structure of this roadway consists of the 9 to 15 inches of HMA and the 5 to 10 inches of base. The thickness of HMA is reasonable, but some lower layers are severely stripped (See core samples in Sections 1 and 3) as previously stated. The deterioration of HMA occurred at different depths.

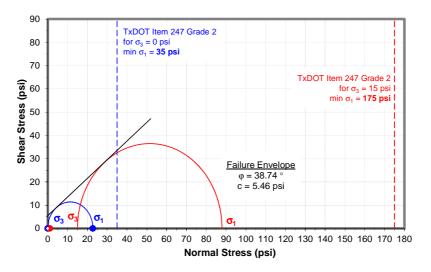
Figure 6: Triaxial Compression of the 50/50 Blend Materials

6. At the zero confinement pressure, the axial compressive strength of blend material reached 22.8 psi whereas axial strength at the 15-psi confinement reached 87.9 psi. These results failed the requirements of a Grade 2 aggregate as per TxDOT Item 247 [TxDOT 2004]. Therefore, this blend material seems to require stabilizer in order to achieve enough strength as base-course material.

To achieve early strength development and good durability for moisture susceptibility, cement was chosen as a stabilizer. Its replacement level was decided to 2%, 3%, and 4% for a FDR base mix design evaluation. The maximum dry density and optimum moisture content of mixture treated with 3% cement were 129.5 lbs/ft³ and 7.8%, respectively. Moisture contents were adjusted for each of the remaining cement contents (2 and 4%) at 1/4 % moisture per 1% cement.

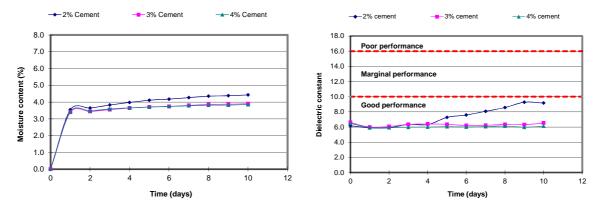
Figure 7: Tube Suction Test Results

As presented in Figure 7-(a) and 7-(b), for all mixtures, dielectric value (DV) increased as absorbed moisture content (MC) increases. All mixtures have low moisture susceptibility with the corresponding good DV below 10. Increasing cement content improved the moisture susceptibility resistance of FDR mixture.

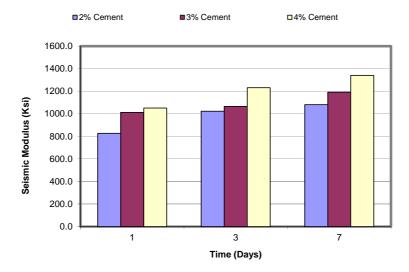
Figure 9: Seismic Modulus Development over Time for Different Mixtures

Figure 9 presents seismic modulus (SM) development of each cement-treated mixture during curing. The SM of the cement-stabilized mixtures increases over time and with increment of cement content. Currently, there is no magic SM number to determine a good base-course material at a certain age, but typical values of SM for cement-stabilized base material range from 1, 000 psi to 5,000 ksi at 7 days. Therefore, the MS for cement-treated FDR mixtures for FM 1887 roadway seem to be good enough for base course application.

Based on the criteria previously stated, the suggested mix design would be 50/50 blend of existing base and RAP materials containing 3% cement which satisfied the necessary strength and moisture susceptibility requirement.
